Contract #: 04-0120F4Cty: SF/ALA Rte: 80 PM: 13.2/13.9File #: 69.28**WELDING INSPECTION REPORT****Resident Engineer:** Siegenthaler, Peter**Address:** 333 Burma Road**City:** Oakland, CA 94607**Report No:** WIR-017798**Date Inspected:** 14-Oct-2010**Project Name:** SAS Superstructure**OSM Arrival Time:** 1900**Prime Contractor:** American Bridge/Fluor Enterprises, a JV**OSM Departure Time:** 700**Contractor:** Zhenhua Port Machinery Company, Ltd (ZPMC), Changxing Island **Location:** Shanghai, China**CWI Name:** See Below**CWI Present:** Yes No**Inspected CWI report:** Yes No N/A**Rod Oven in Use:** Yes No N/A**Electrode to specification:** Yes No N/A**Weld Procedures Followed:** Yes No N/A**Qualified Welders:** Yes No N/A**Verified Joint Fit-up:** Yes No N/A**Approved Drawings:** Yes No N/A**Approved WPS:** Yes No N/A**Delayed / Cancelled:** Yes No N/A**Bridge No:** 34-0006**Component:** OBG**Summary of Items Observed:**

**OBG Bay 14**

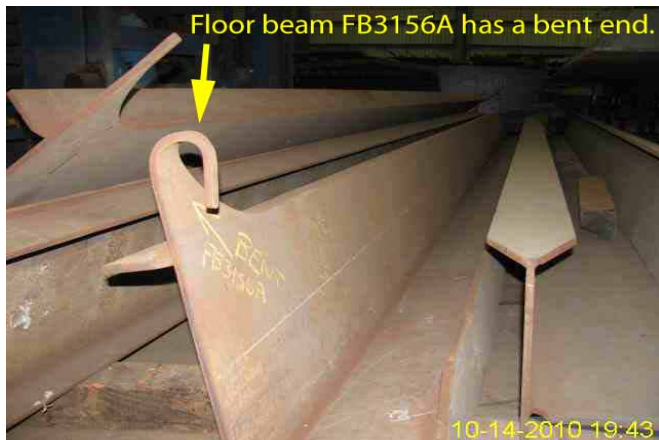
This QA Inspector observed floor beam FB3156-001 has handling damage and the pointed end that gets a CJP weld has a "U" shape bend of approximately 190 degrees. This floor beam has green tag #13039 attached to it. ABF representative Mr. Kelvin Cheung indicated this floor plate had previously been identified and "Red Tagged" along with floor beam FB3132-001 end plate as having been damaged. Kelvin said the red tag appears to have become detached from FB3156-001 and that he will follow up with an email to dayshift personnel to have a new red tag issued. See the photograph below for additional information.

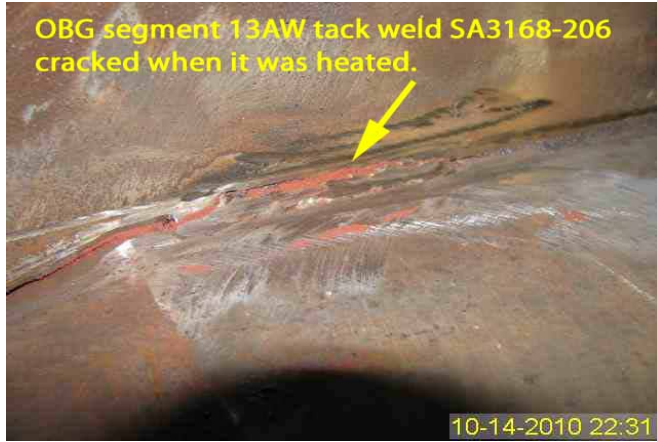
This QA Inspector observed ZPMC positioned and tack welded OBG segment 13W plate SA3179 to floor beam FB3188A. ZPMC used a cutting torch to cut a small amount of material from the surface of the top slot to allow clearance between the top FB3188A "T" plate and SA3179. Prior to installation of SA3179 this area was then ground to remove the flame cut oxide surface. This QA Inspector observed ZPMC welder Mr. Rao Wei, stencil 049972 used shielded metal arc welding process to tack weld SA3179, FB3216, FB3219, other floor beams and temporary braces in OBG segment 13AW and 13BW. This QA Inspector measured a welding current of approximately 160 amps, Mr. Rao Wei appeared to be certified to make these welds, the welding electrodes were stored in a portable rod oven which was warm to the touch and the base materials were heated with a torch prior to welding. Items observed on this date appeared to generally comply with applicable contract documents.
